Fatigue crack growth rates of  
high-magnesium aluminum-magnesium alloys  
as influenced by solution treatment time and  
alloy content.

# THESIS

FATIGUE CRACK GROWTH RATES OF HIGH-  
MAGNESIUM ALUMINUM-MAGNESIUM ALLOYS AS  
INFLUENCED BY SOLUTION TREATMENT TIME  
AND ALLOY CONTENT

MASTER OF SCIENCE IN MECHANICAL ENGINEERING

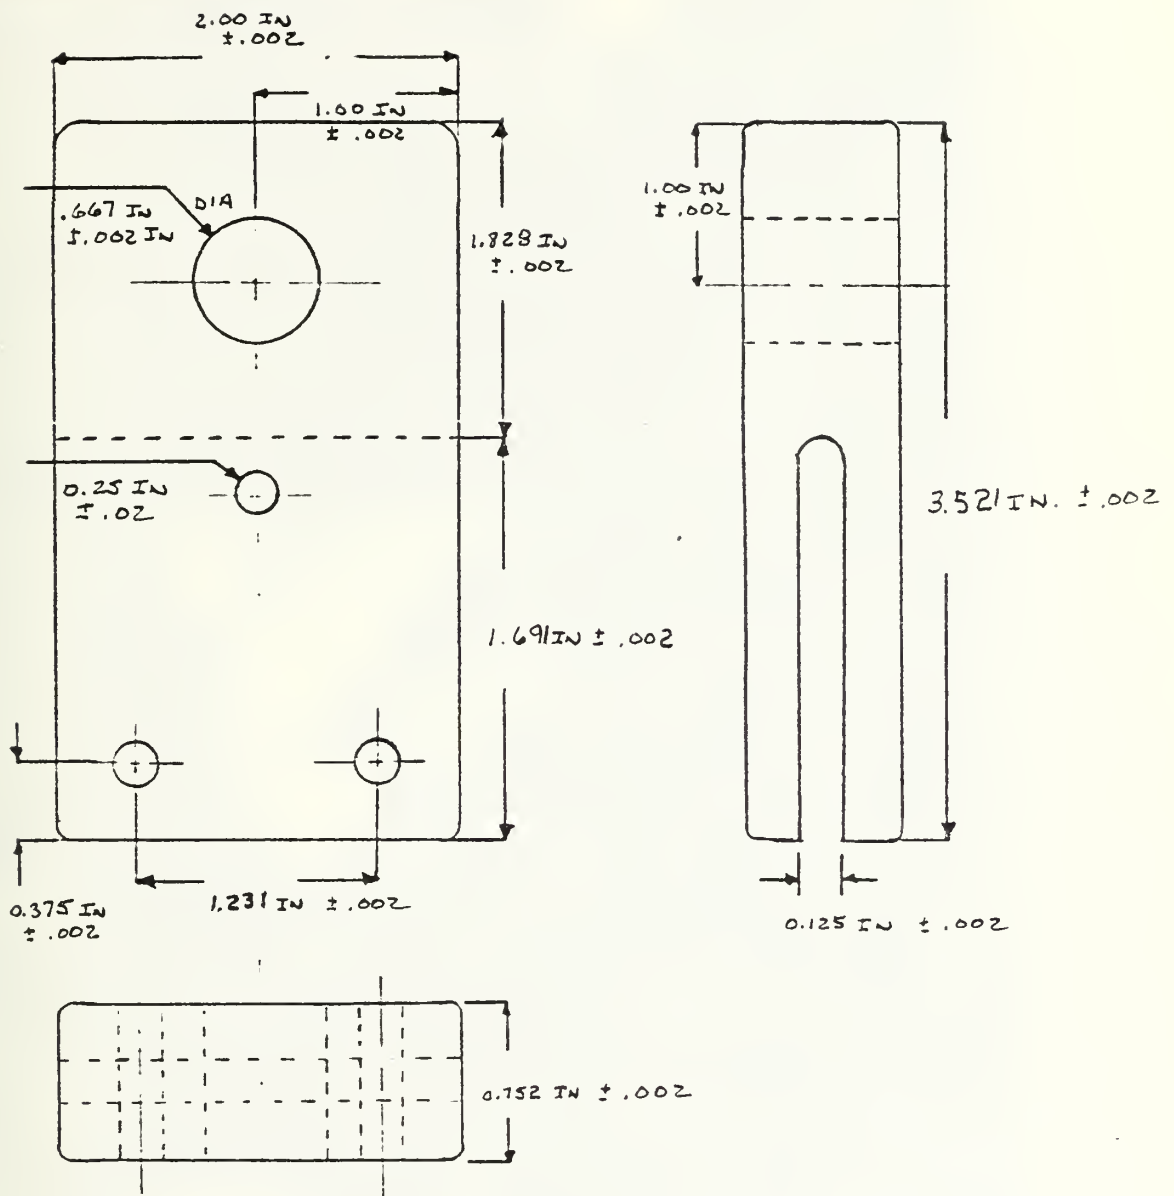
FIGURE 2.1 . DIAGRAM OF CLEVIS ASSEMBLY FABRICATED FROM 4140 STEEL

The clevis assembly was designed to pull a two-pin tensile specimen as outlined in Reference 4. Due to premature failure of the test specimen in the pin region, the test specimens had to be redesigned. This also required a clevis design different from that required in Reference 4. The material selected for the clevis assembly was 4140 steel. The heat treatment procedure was in accordance with Reference 6: austentize at  $871^{\circ}\text{C}$  for one hour, oil quench and temper at  $482^{\circ}\text{C}$  for one hour. Both pieces were wrapped in nickel foil with titanium chips added to act as an oxygen getter. The clevis assembly was designed initially in accordance with Reference 8, but premature failure of the sample in the clevis region required re-design of the assembly as shown in Figure 2.1. The pins that were initially used in the clevis assembly were replaced with stainless steel bolts. By using the bolts in the clevis assembly it was possible to increase the normal force on the specimen surface, which distributed the load more uniformly, and the problem with premature failure at the clevis region was solved with no distortion of the bolt holes in the specimen during the fatigue test.

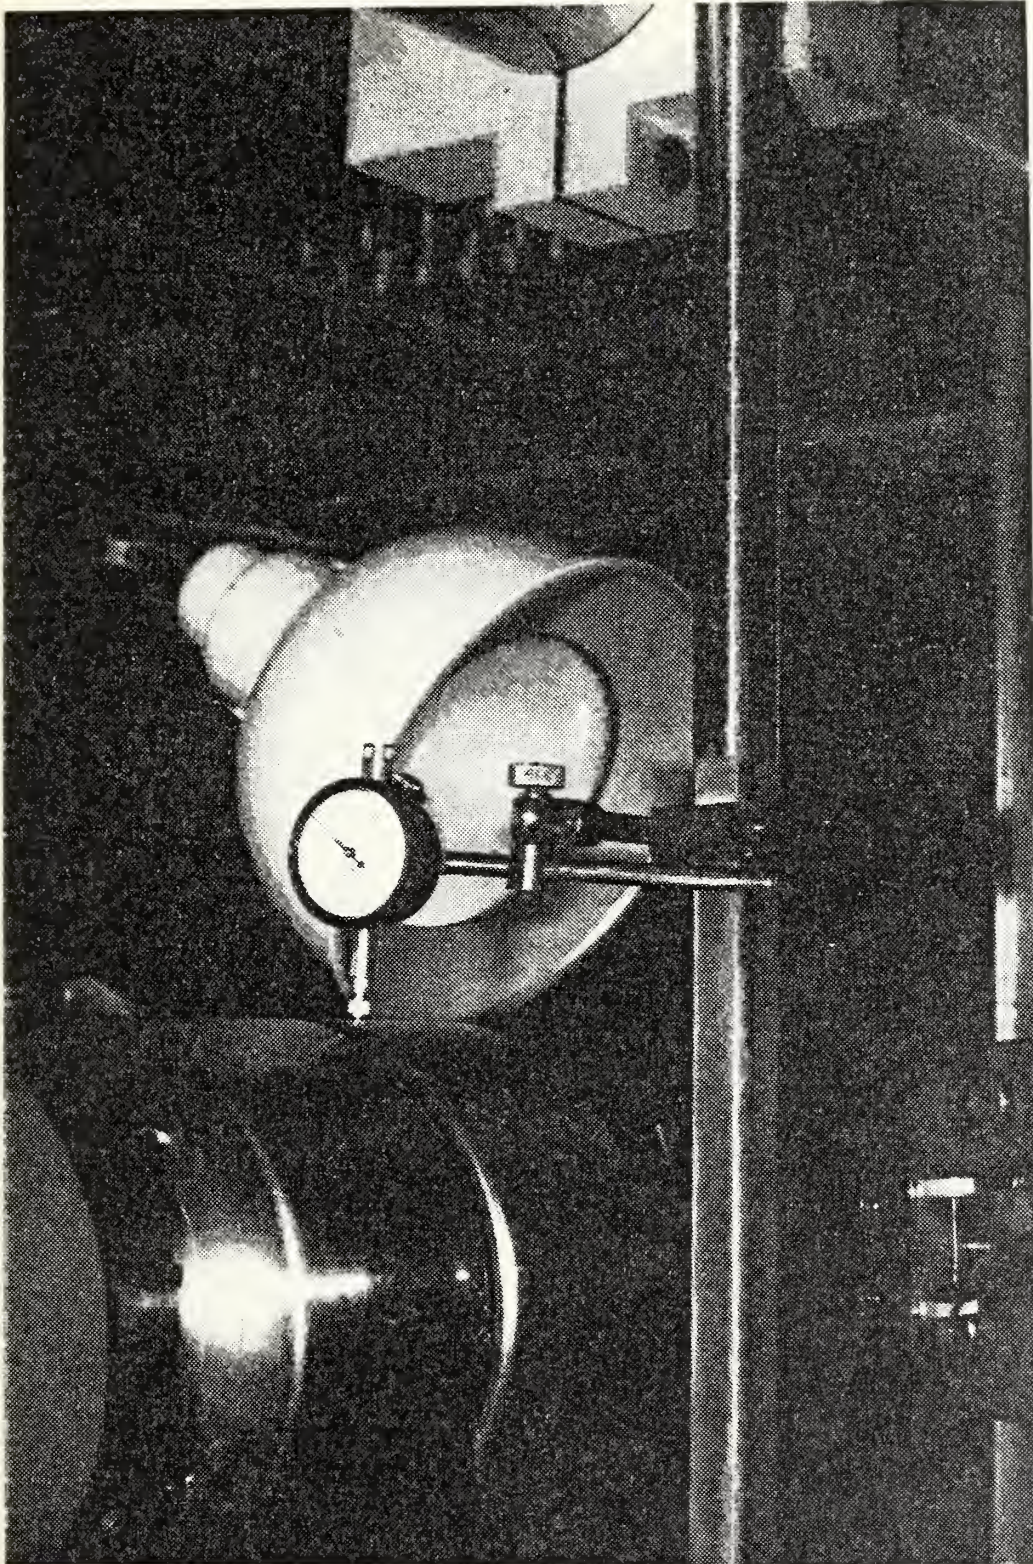
FIGURE 2.2 THE ALIGNMENT APPARATUS AS MOUNTED ON THE MTS MACHINE SHOWING THE DIAL INDICATOR AND LOAD CELL, DURING CENTERING OF LOAD CELL. THE GRIPS AND HYDRAULIC RAM ARE BELOW THE BAR.

An alignment device was designed and fabricated to assure accurate alignment of the testing machine and specimen axis (Figure 2.2). The reference bar was held in place by two brackets which were machined from aluminum. Use of aluminum prevented damage to the load frame assembly when the alignment fixture was tightly secured (Figure 2.3). Both ends and the center of the reference bar were machined flat so that when the assembly was rigidly mounted all surfaces remained square. The center of the reference bar was calibrated in 3.175 mm (0.125 in) increments to facilitate the alignment procedure. A dial indicator was mounted on the bar and positioned so that full movement of the load cell could be measured. The load cell was moved horizontally to full left and right deflections in the crosshead and the readings were taken from the dial indicator. These readings were then added together and their sum halved to give the mean load cell position in the crosshead. This procedure was repeated several more times to verify the load cell was completely centered. To further verify the results of the dial indicator readings a machinist square was positioned on the center of the reference bar and a set of measurements was taken. This procedure insured that the material testing machine load cell was accurately aligned.

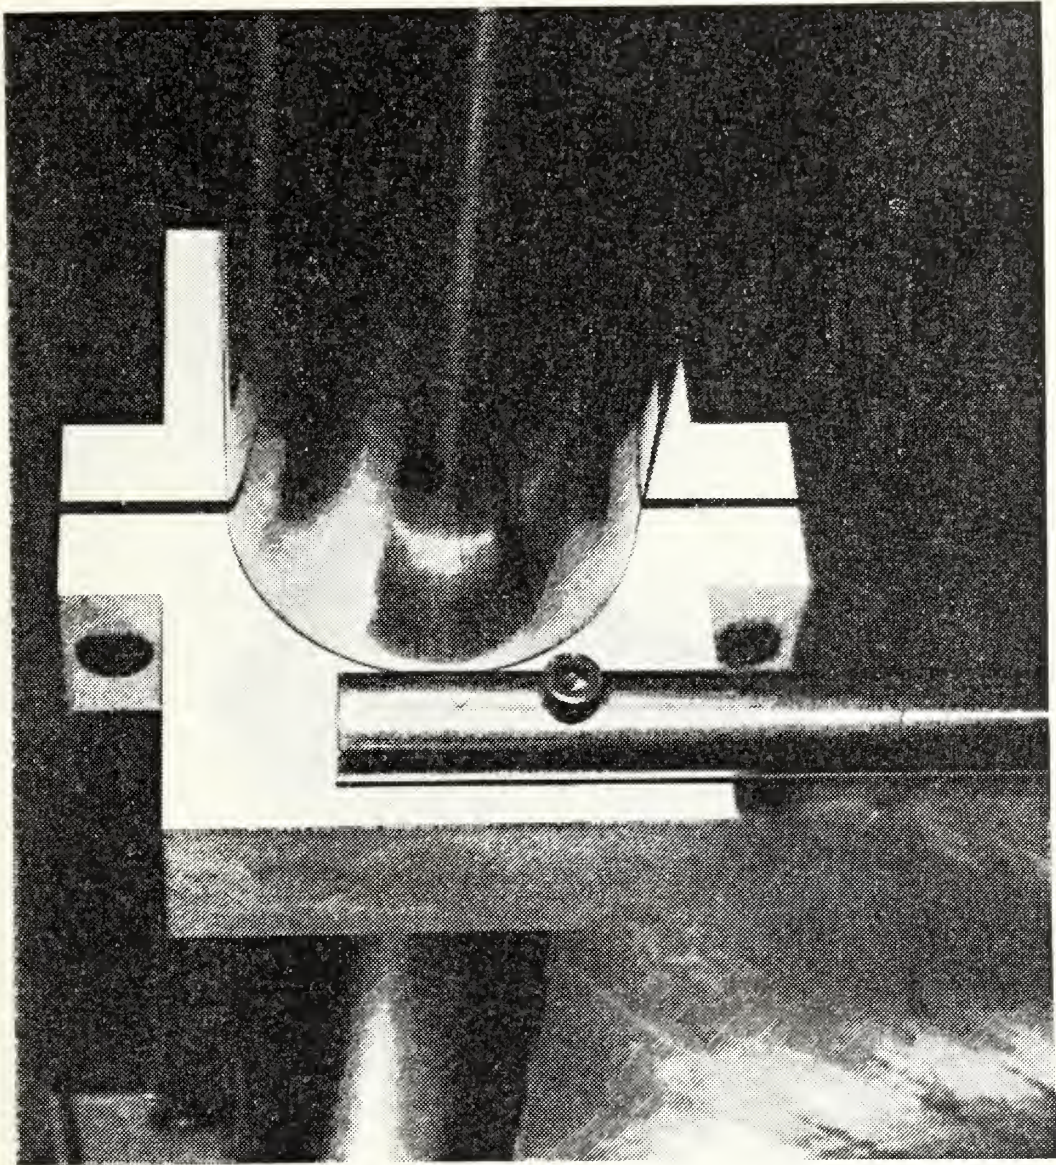
FIGURE 2.3 THE ALIGNMENT BAR CLAMP AS MOUNTED ON THE LEFT  
SIDE OF THE LOAD FRAME ASSEMBLY CONSTRUCTED OF ALUMINUM  
AND SUPPORTING STEEL ALIGNMENT BAR

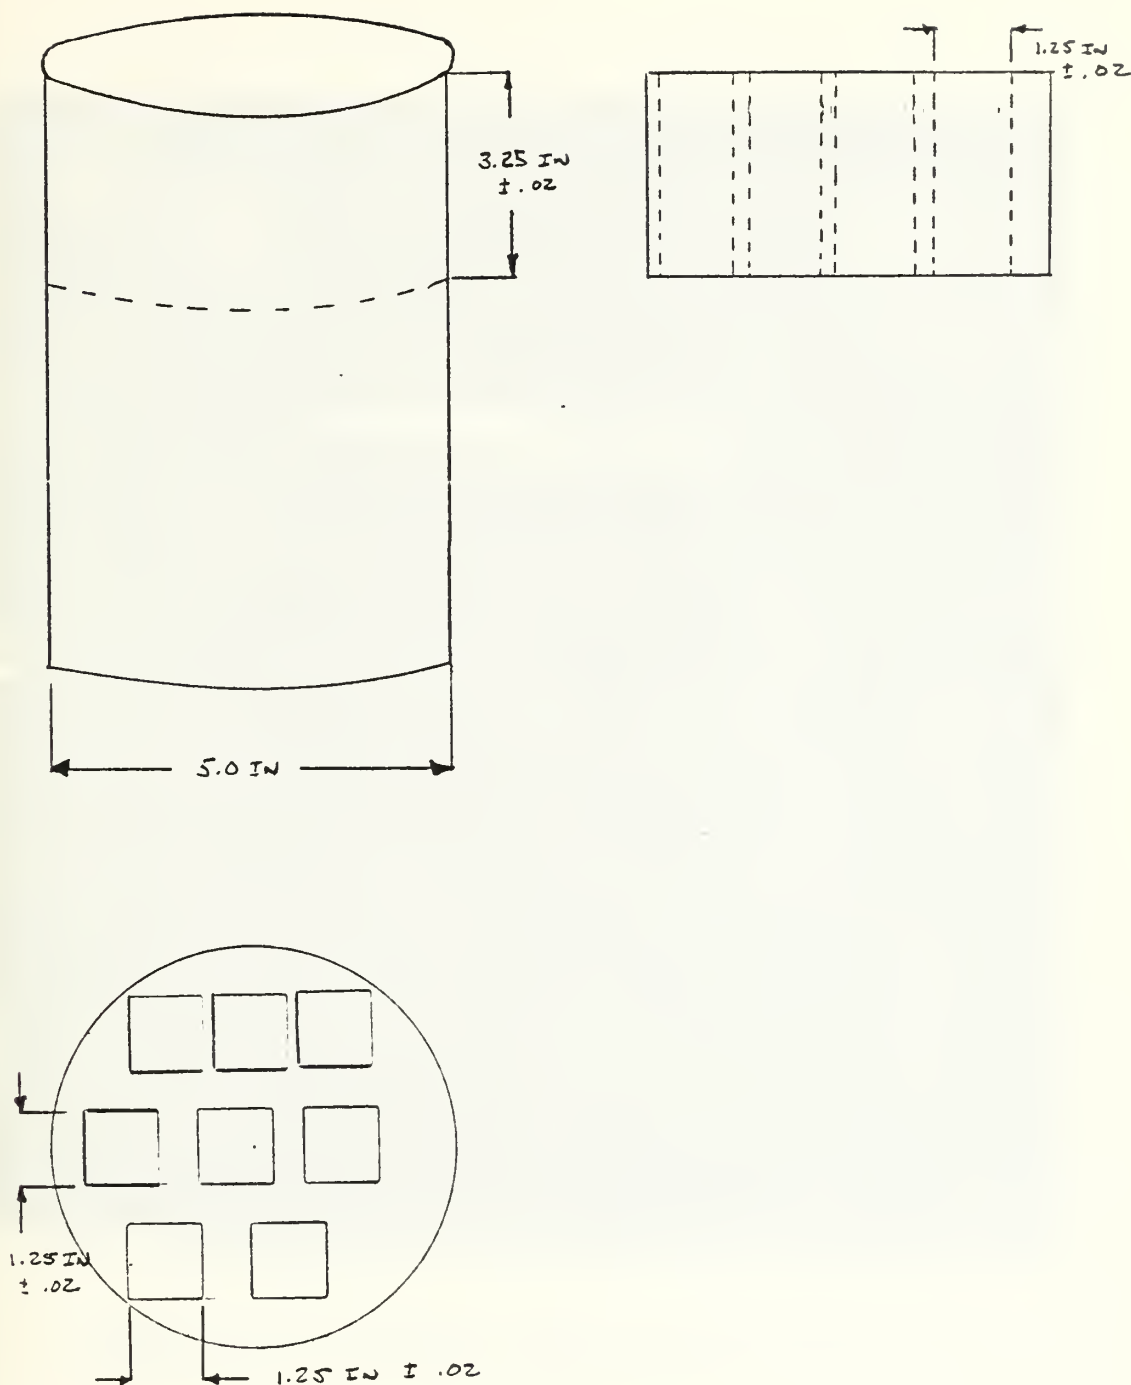
Figure 2.4 DIAGRAM SHOWING THE SECTIONING OF THE AS-CAST INGOT TO OBTAIN BILLETS FOR THERMO-MECHANICAL PROCESSING.

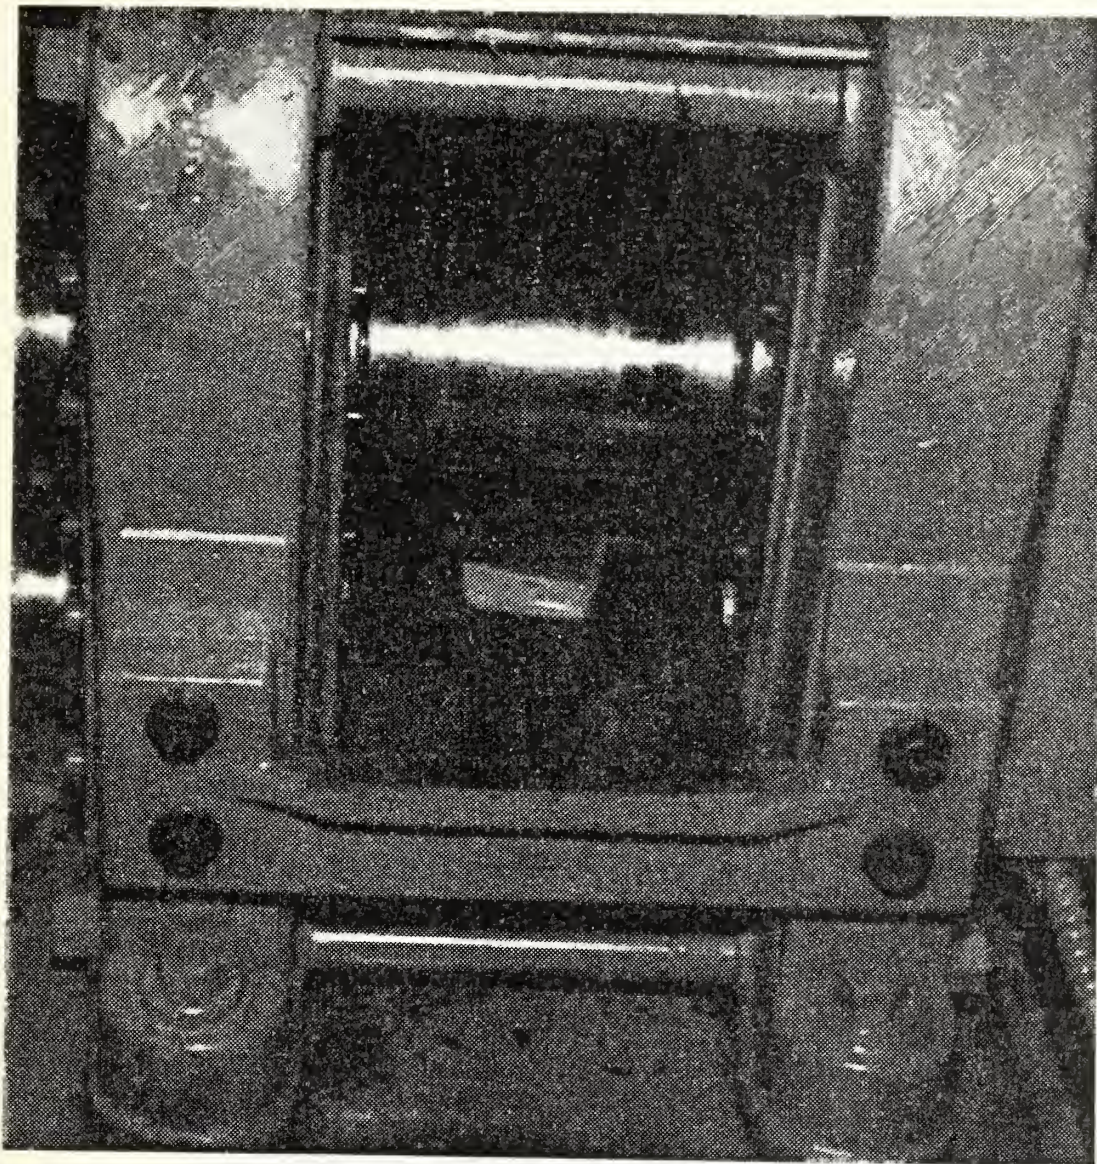
Figure 2.5 A ROLLING BILLET ON THE RUN IN  
THE TABLE OF THE ROLLING MILL

billet, a four-pass sequence was utilized as outlined by Johnson {Ref. 2}, (Figure 2.5). The final thickness was 3.6 mm (0.140 in) in all cases, and an as-rolled sample is shown in Figure 2.6.

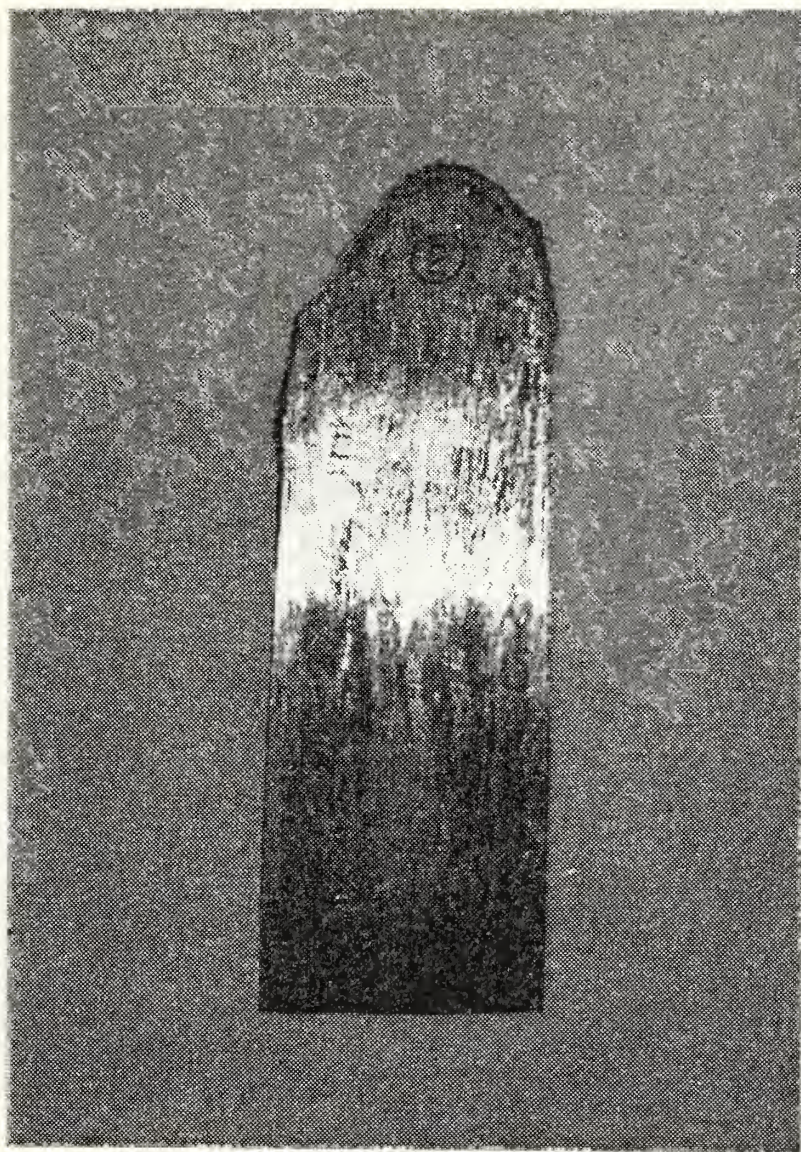
Figure 2.6 AN AS-ROLLED SAMPLE OF Al-10.2 Wt PCT Mg-  
0.52 Wt PCT Mn ALLOY; SAMPLE WIDTH IS APPROXIMATELY  
THREE INCHES.

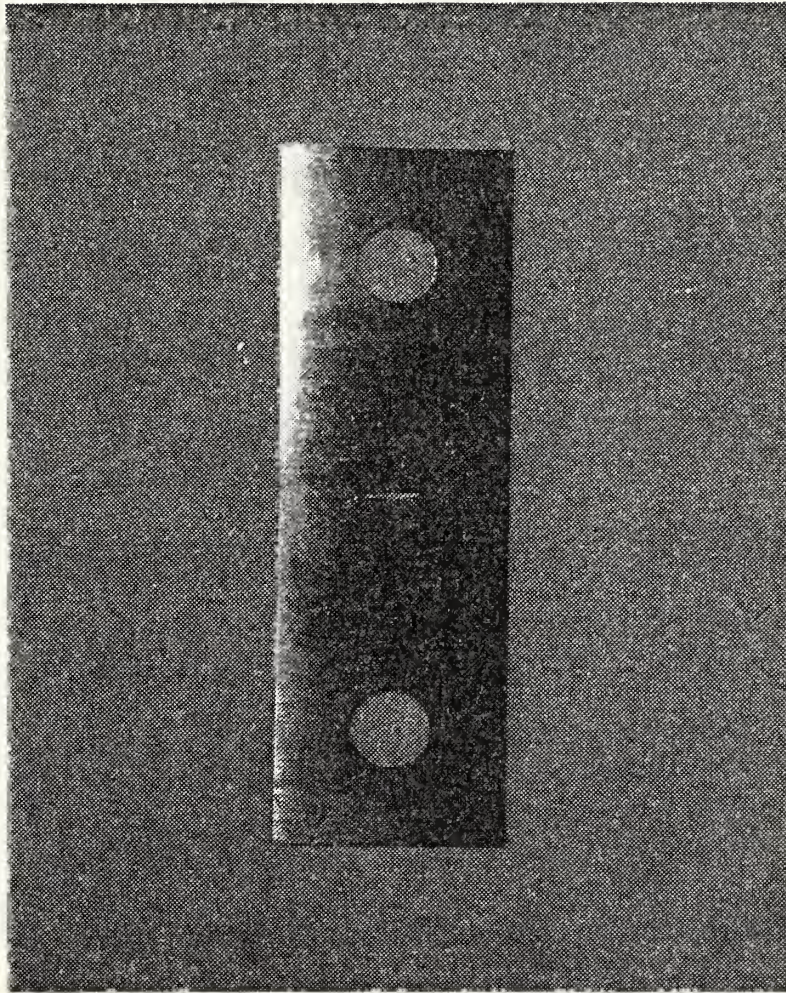
Figure 2.7 ORIGINAL DESIGN OF MACHINED SPECIMEN WITH  
LARGE PIN-HOLES AT EACH END TO FIT IN THE  
CLEVIS ASSEMBLY

Following rolling, the billets (Figure 2.7) were machined in accordance with Reference 4. Premature cracking in the area of the pinhole of the sample was noted in crack growth measurements and this required a design modification (Figure 2.8). The final design for the crack initiator notch was chosen after several crack growth measurements were performed using the 7075-T6 alloy test material. This consisted of drilling a 4.98 mm (0.196 in) hole in the center of the specimen and then making a saw cut out from both sides of the hole. The sawcuts were required to be accurate to ensure that they were square with the sample ends. This ensured that the load distribution was symmetrical with respect to the specimen notch. The details of the crack initiator notch geometry are shown in Figure 2.9; also of note is the 30 degree crack angle at the notch tip, also shown in Figure 2.9.

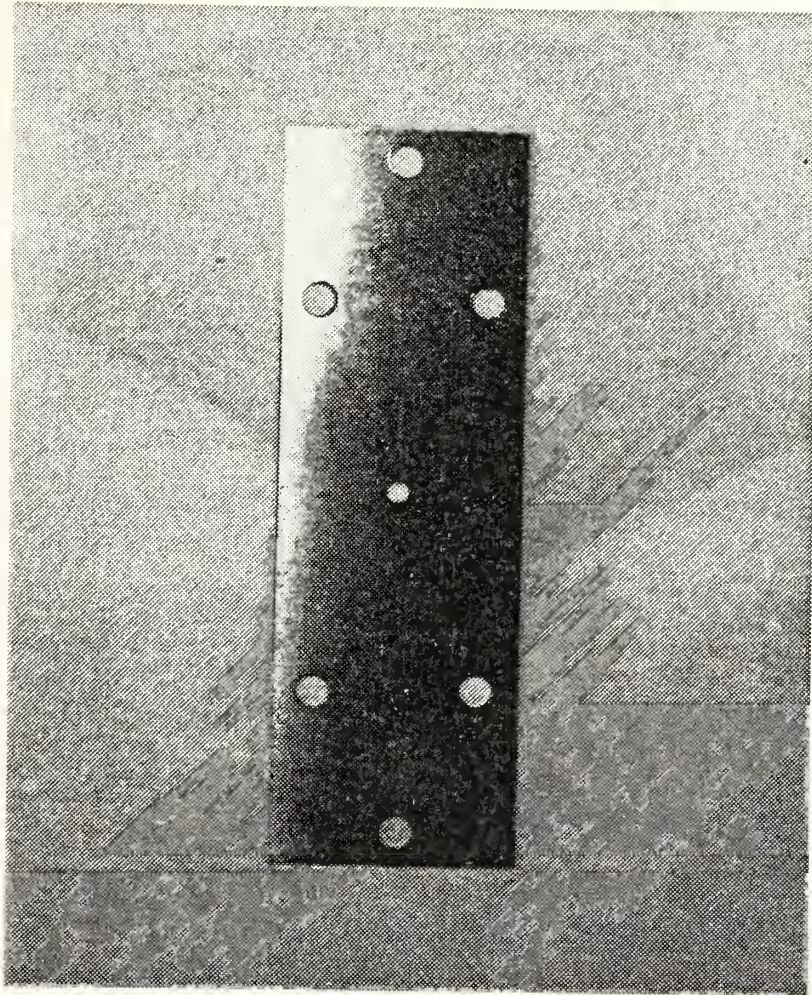
Figure 2.8 REDESIGN OF MACHINED SPECIMEN. THREE  
SMALLER HOLES WERE SUBSTITUTED FOR LARGER PIN-  
HOLES IN ORIGINAL DESIGN.

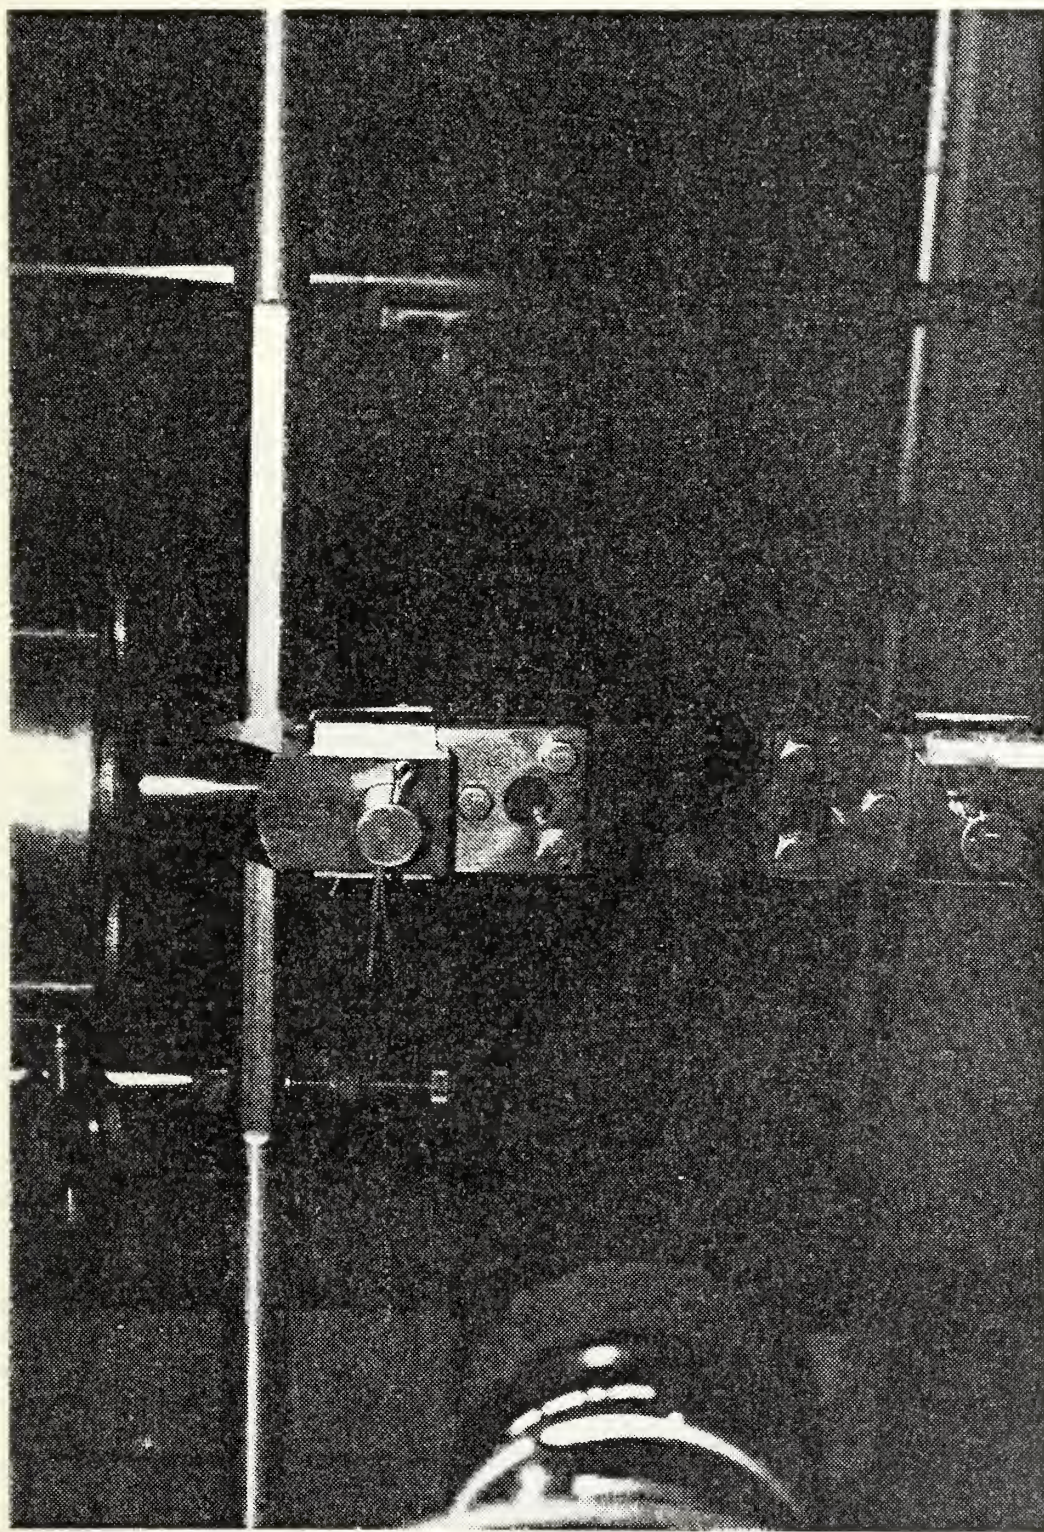
FIGURE 3.1 SPECIMEN MOUNTED IN THE CLEVIS ASSEMBLY; CHECK FOR ALIGNMENT  
USES THE DIAL INDICATOR; ABOVE IS THE LOAD CELL AND BELOW IS  
THE HYDRAULIC RAM

All fatigue crack growth measurements reported here were made using an MTS Model 810 servo-hydraulic testing machine. To conduct a test, the load cell was aligned using the fixture described previously. The specimen was then installed in the machine using the clevis assembly. In some cases, the specimens were not flat; however, the fifty pound preload applied prior to testing corrected the curvature and this was checked using an engineer's square.

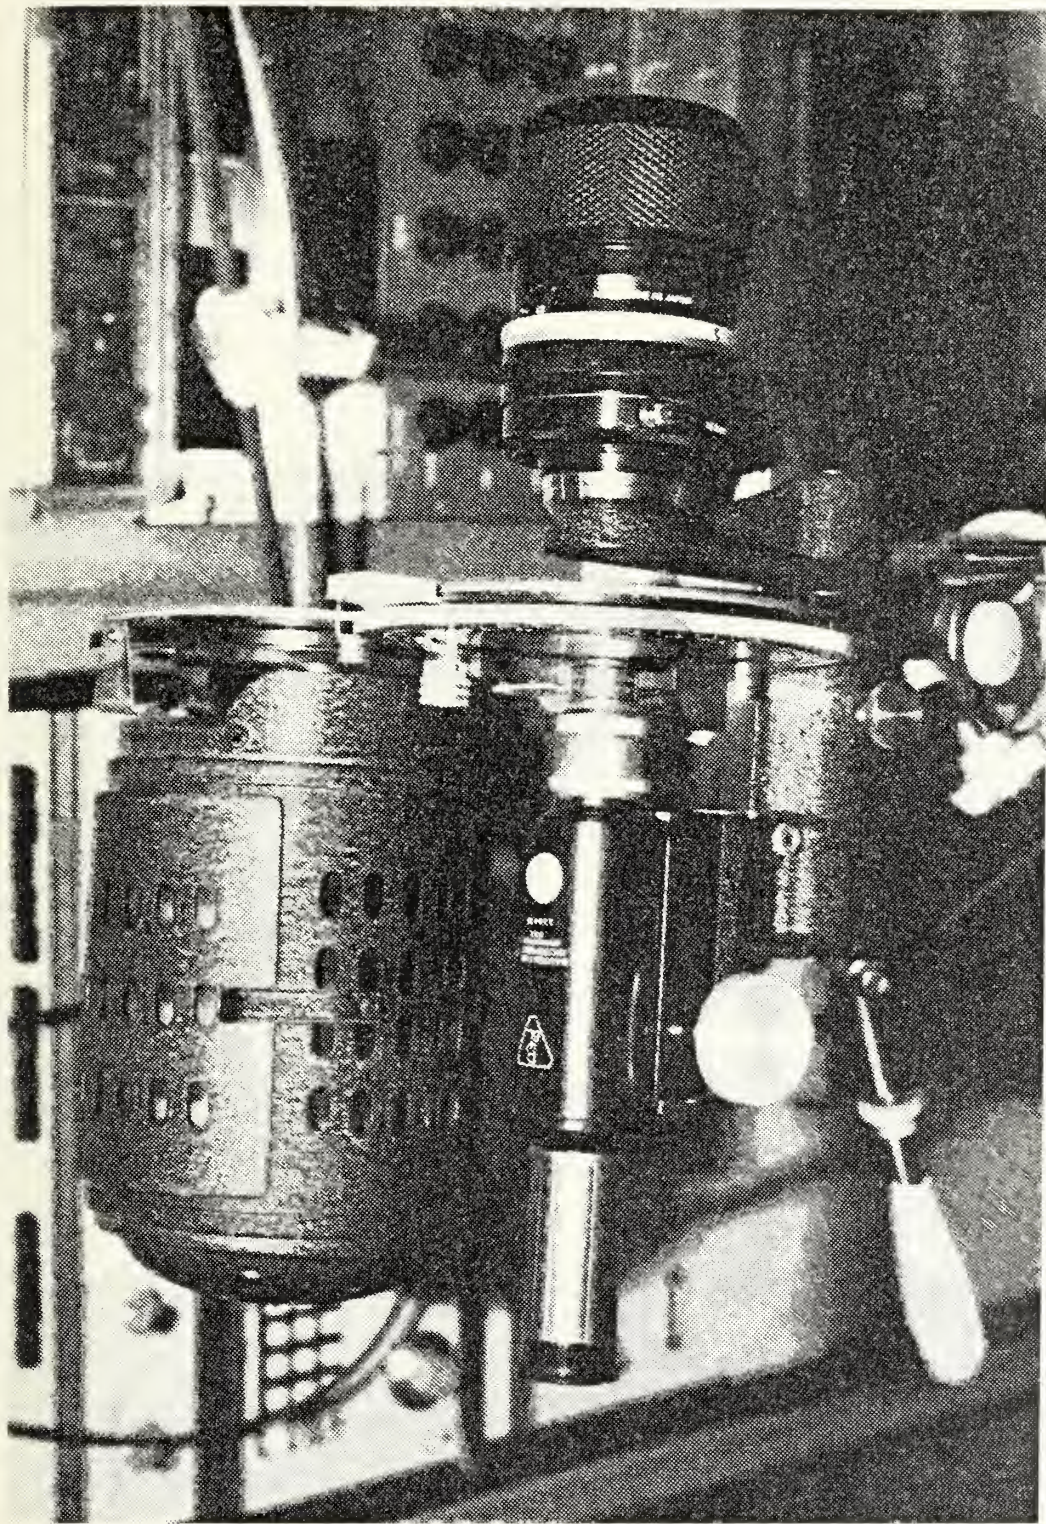
FIGURE 3.2 OPTICAL DEVICE USED TO MEASURE CRACK LENGTH, A BAUSCH & LOMB  
22.7 MM, 6X TELESCOPE IN CONJUNCTION WITH A NIKON 86 MM ZOOM LENS

A haversine waveform was selected from the digital function generator of the MTS machine. This, with the fifty pound pre-load ensured that a tensile load was applied to the specimen at all times. Fatigue crack length measurements were made as a function of elapsed cycles by means of an optical device shown in Figure 3.2. This was used following the procedures as outlined in Reference 7. The device consists of a Bausch and Lomb 22.7 mm, 6X telescope in conjunction with a Nikon 86 mm zoom lens. The surface of the specimen was sprayed with steel blue layout fluid to make the crack more visible. Reference marks were applied in .381 mm (0.015 in) divisions from the notch tip to the edge of the sample. By using a stationary optical device and reference marks as opposed to a

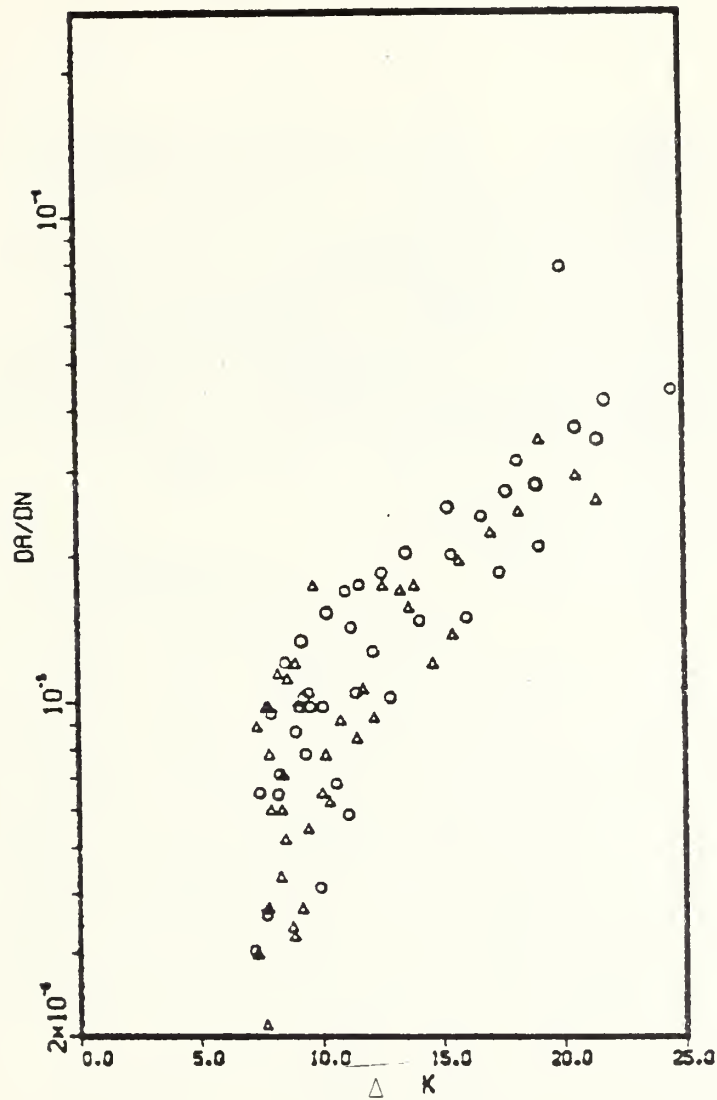
FIGURE 4.1 FATIGUE CRACK PROPAGATION DATA FOR 7075-T6 ALLOY

The 7075-T6 alloy was chosen for initial testing due to the availability of well documented data for comparison and validation of test procedures, and also the local availability of the material in large quantities. The crack growth data obtained for this material as shown in Figure 4.1,  $\Delta k$  and follows closely the data reported in Reference 9.

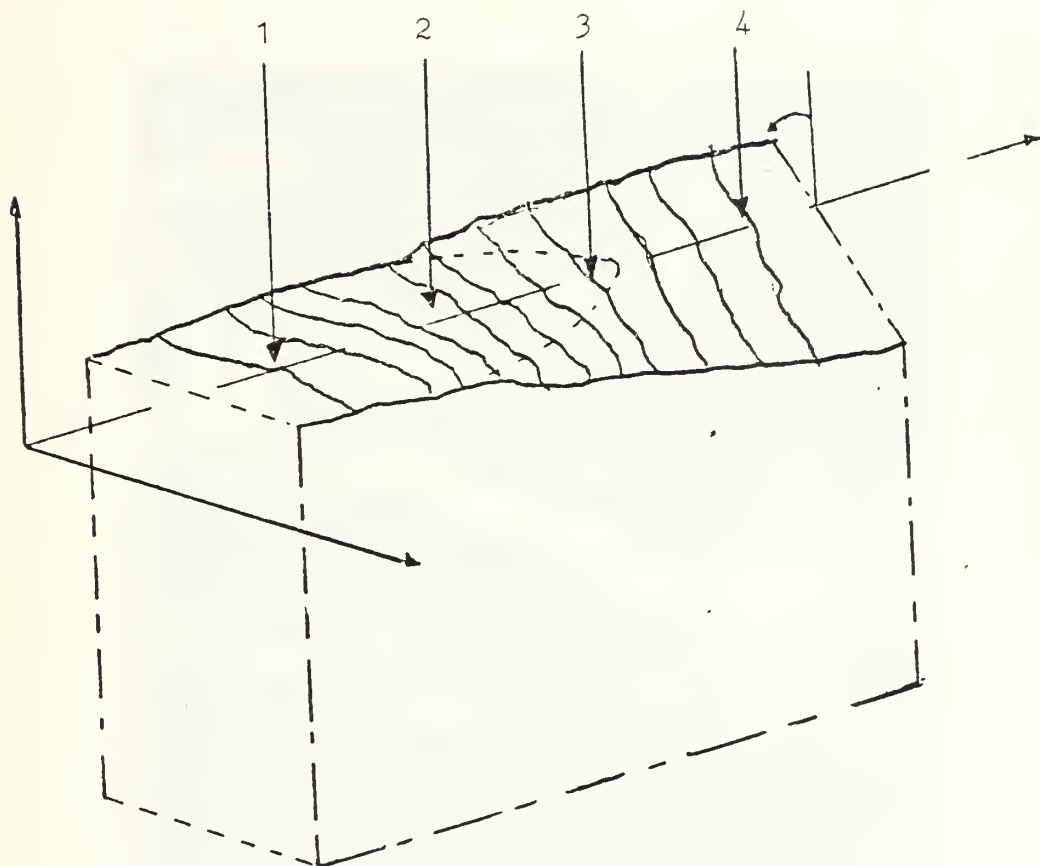
FIGURE 4.2 A SCHEMATIC SHOWING SCANNING ELECTRON MICROGRAPH LOCATIONS ON THE FATIGUE CRACK SURFACE FOR THE 7075-T6 AND THE MANGANESE, AND COPPER CONTAINING ALLOYS

Fatigue crack surfaces were examined by scanning electron microscopy (SEM). Fractograph locations for all SEM work are shown in Figure 4.2 and fractographs of the 7075-T6 alloy are shown in Figure 4.3. Observed in the fractographs are small "dimples", microvoids and crack

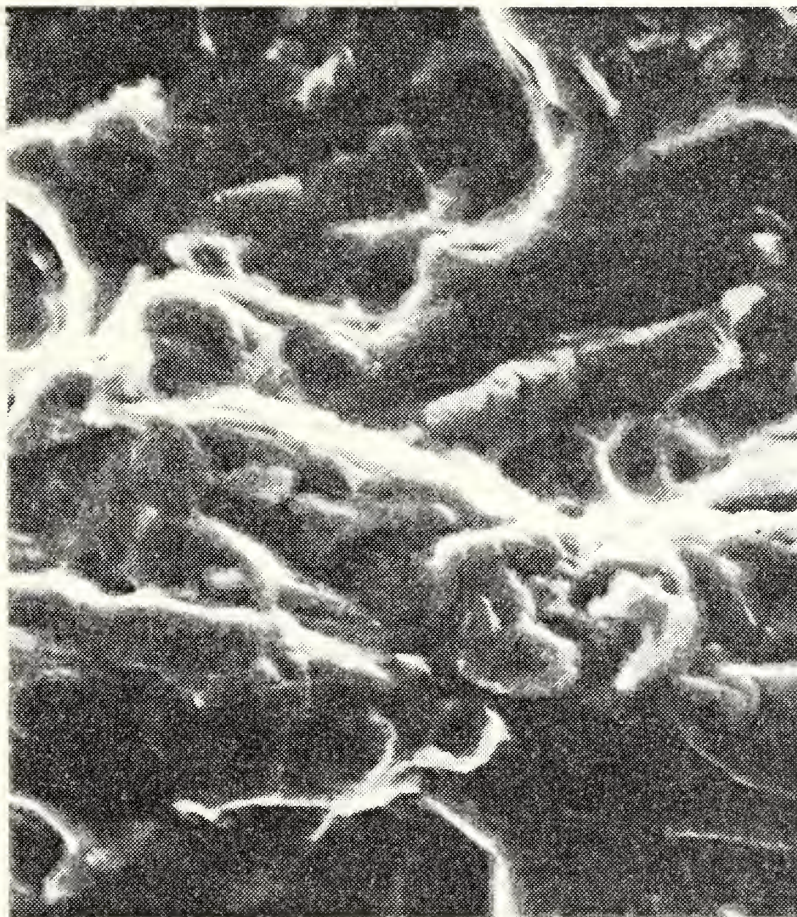
FIGURE 4.3     FRACTOGRAPH OF THE FATIGUE CRACK GROWTH SURFACE  
                     FOR THE 7075-T6 ALLOY

ridges. The appearance of the crack surface follows very closely that described in Reference 10 for 7075-T6 and indicates that a uniaxial load was applied to the test specimen. The voids observed were probably nucleated by iron and silicon-rich second phase particles present in the alloy. It has been proposed by Reference 9 that the presence of these compounds in the alloy causes a reduction in fracture toughness.

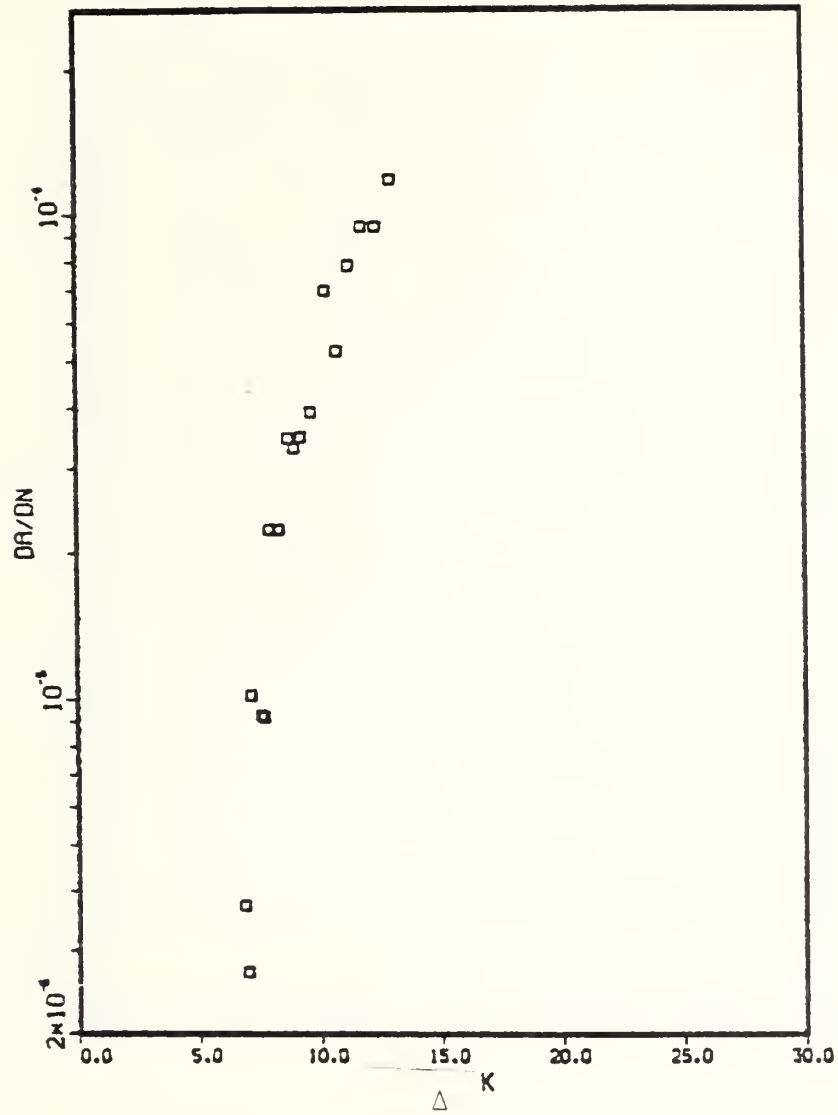
FIGURE 4.4 FATIGUE CRACK PROPAGATION DATA FOR THE Al-10.2 WT PCT Mg-0.52 WT PCT Mn ALLOY SOLUTION TREATED FOR NINE HOURS

The crack propagation data obtained for the nine hour solution treated Al-10.2 wt pct Mg-0.52 wt pct Mn alloy (Figure 4.4) shows it to be less fatigue crack growth resistant than the 7075-T6 alloy. The alloys appear to have similar threshold values of  $\Delta K$ , about  $7.5 \text{ ksi } \sqrt{\text{in}}$ , below which the crack growth rate decreases rapidly. The twenty-five hour solution treated Al-10.2 wt pct Mg-0.52 wt pct Mn alloy shows an even further degradation in the fatigue crack growth resistance compared to that of the nine hour solution treated alloy as shown in Figure 4.5.

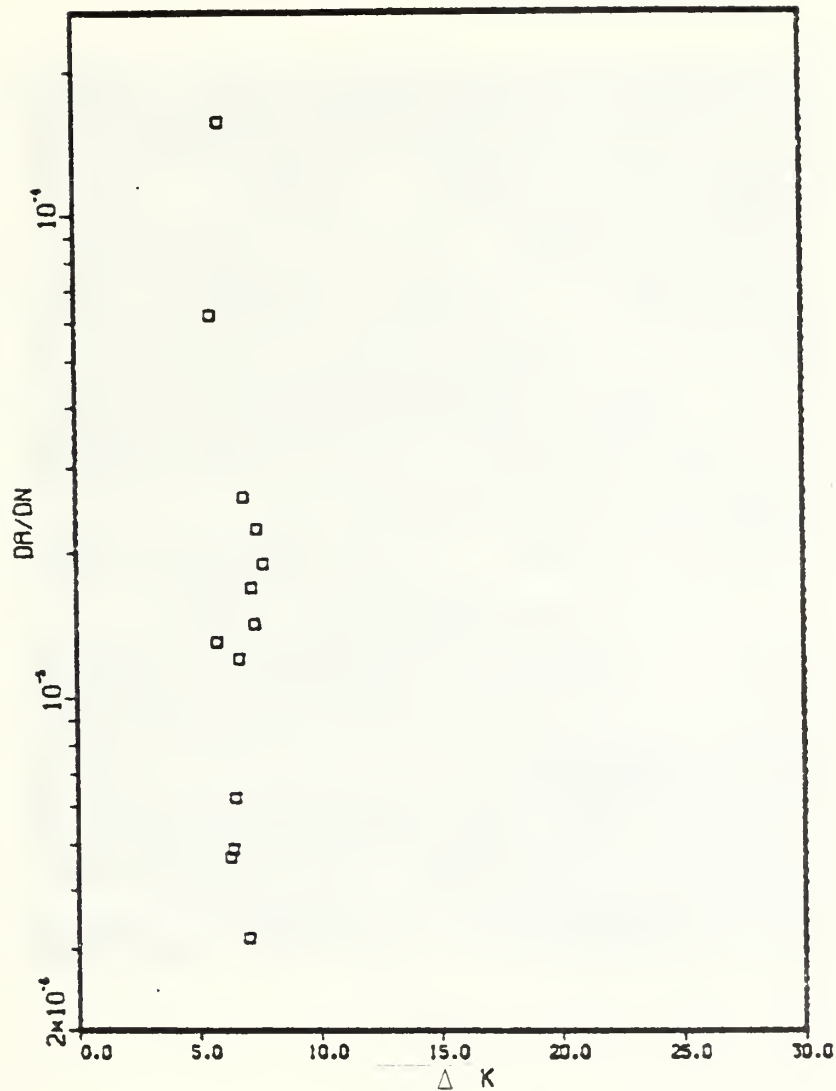
FIGURE 4.5 FATIGUE CRACK PROPAGATION DATA FOR THE Al-10.2  
WT PCT Mg-0.52 WT PCT Mn ALLOY SOLUTION TREATED  
FOR TWENTY-FIVE HOURS.

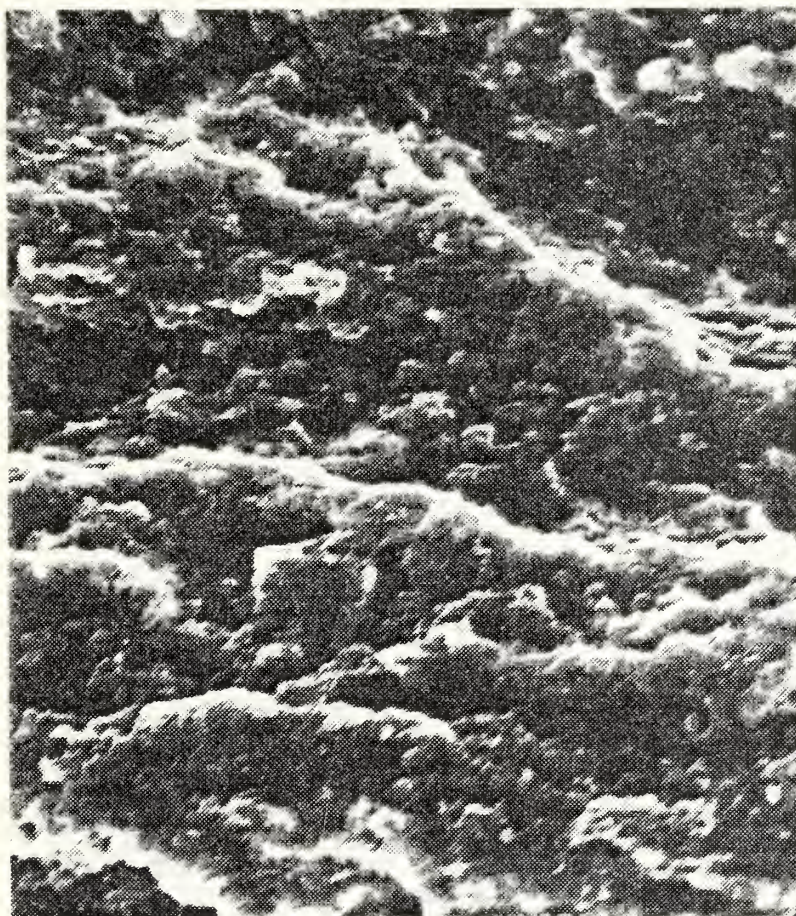
FIGURE 4.6 SCANNING ELECTRON FRACTOGRAPH FOR THE NINE HOUR  
SOLUTION TREATED Al-10.2 WT PCT Mg-0.52 WT PCT Mn ALLOY

Scanning electron microscopy was conducted on both the nine- and twenty-five hour solution treated alloys and the results are shown in Figures 4.6 and 4.7. The fracture surfaces appear similar, with the twenty-five hour solution

The large population of small micro-voids suggest many nucleation sites for such voids and little opportunity for them to grow. This would lead to a small plastic zone and a ready crack growth mechanism. The appearance of these micro-voids over the entire fracture surface indicates that the cracking process occurred by local tensile overload at the crack tip, and crack growth was by the nucleation and link-up of the small micro-voids in the structure. This is reflected in the ready crack growth exhibited by these alloys and low apparent fracture toughness.

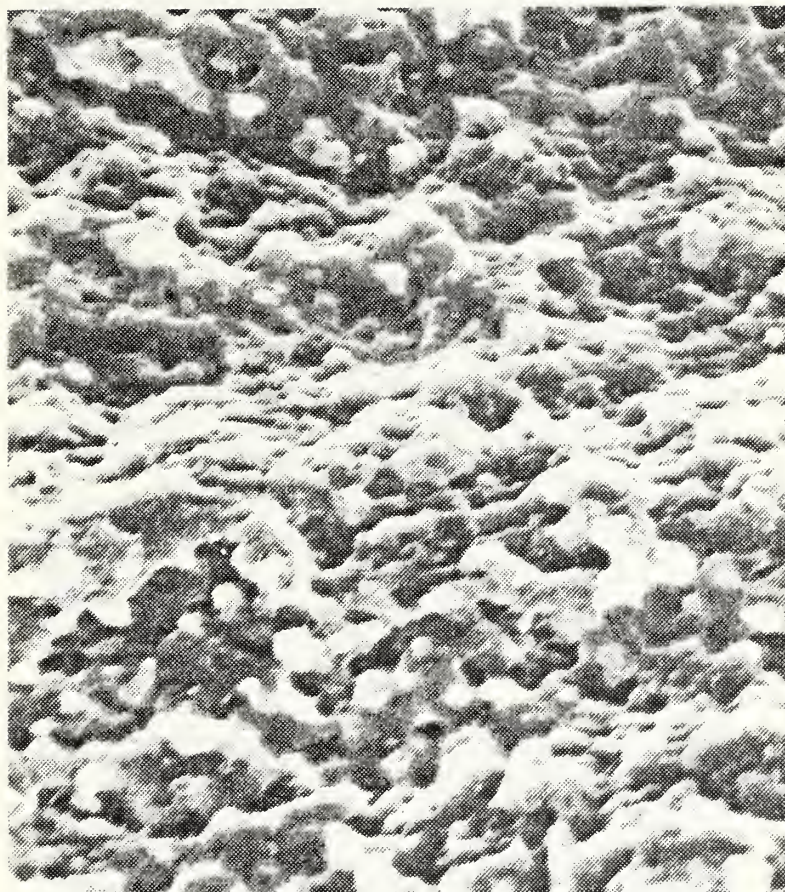
FIGURE 4.7 SCANNING ELECTRON FRACTOGRAPH FOR THE TWENTY-FIVE HOUR SOLUTION TREATED Al-10.2 WT PCT Mg-0.52 WT PCT Mn ALLOY

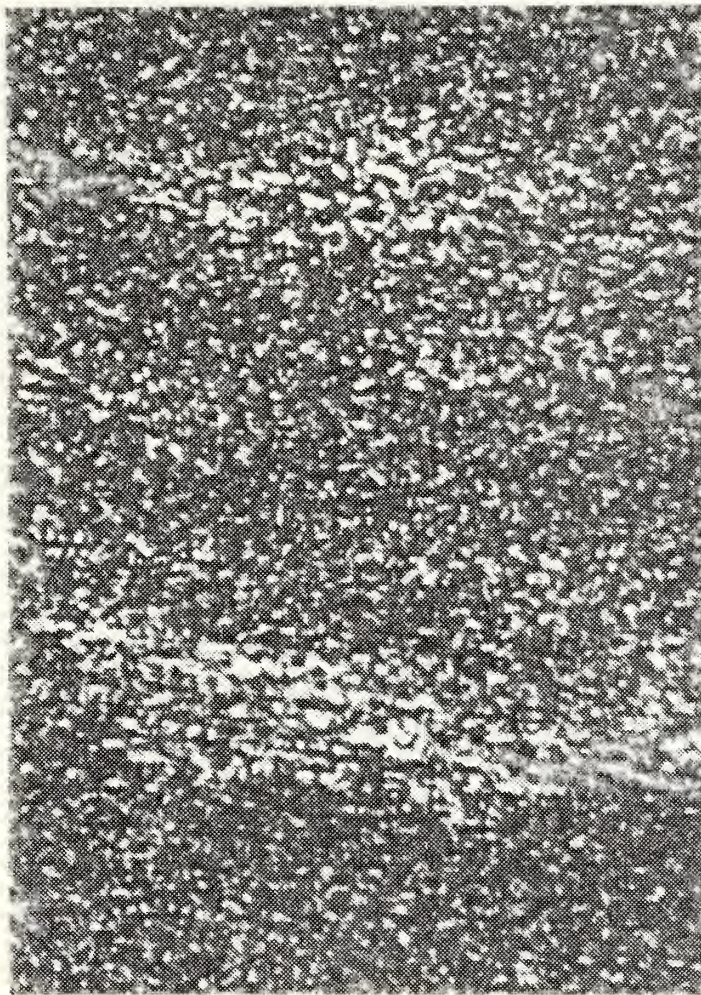
FIGURE 4.8 OPTICAL MICROGRAPH FOR THE NINE HOUR SOLUTION  
TREATED Al-10.2 WT PCT Mg-0.52 WT PCT Mn ALLOY.

Optical micrographs of the nine hour and twenty-five hour solution treated alloys are shown in Figures 4.8 and 4.9 respectively. The relative locations of the micrographs with respect to the crack surface are shown in Figure 4.10. There is little difference in the micrographs between the two

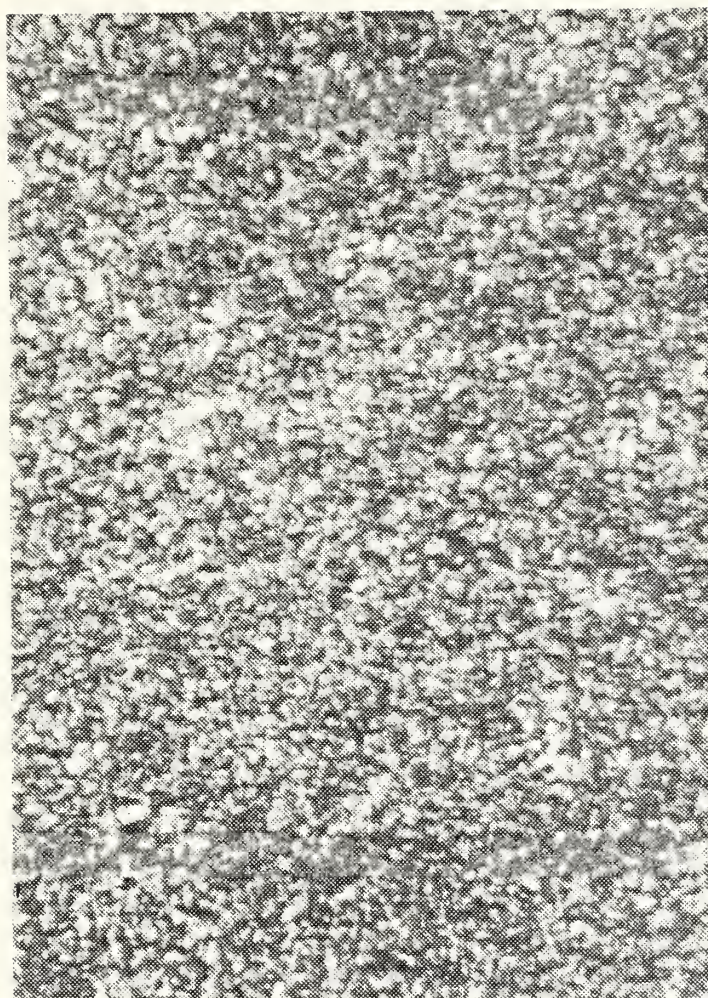
FIGURE 4.9 OPTICAL MICROGRAPH FOR THE TWENTY-FIVE HOUR  
SOLUTION TREATED Al-10.2 WT PCT Mg-0.52 WT PCT Mn ALLOY
